Erwin Ordonez  
Town of Los Gatos Community Planning Department  
110 E. Main Street  
Los Gatos, CA 95031

September 24, 2014

**Re: 341 Bella Vista Avenue, Review of 9/5/14 Revised Plans relative to Existing Tree Protection**

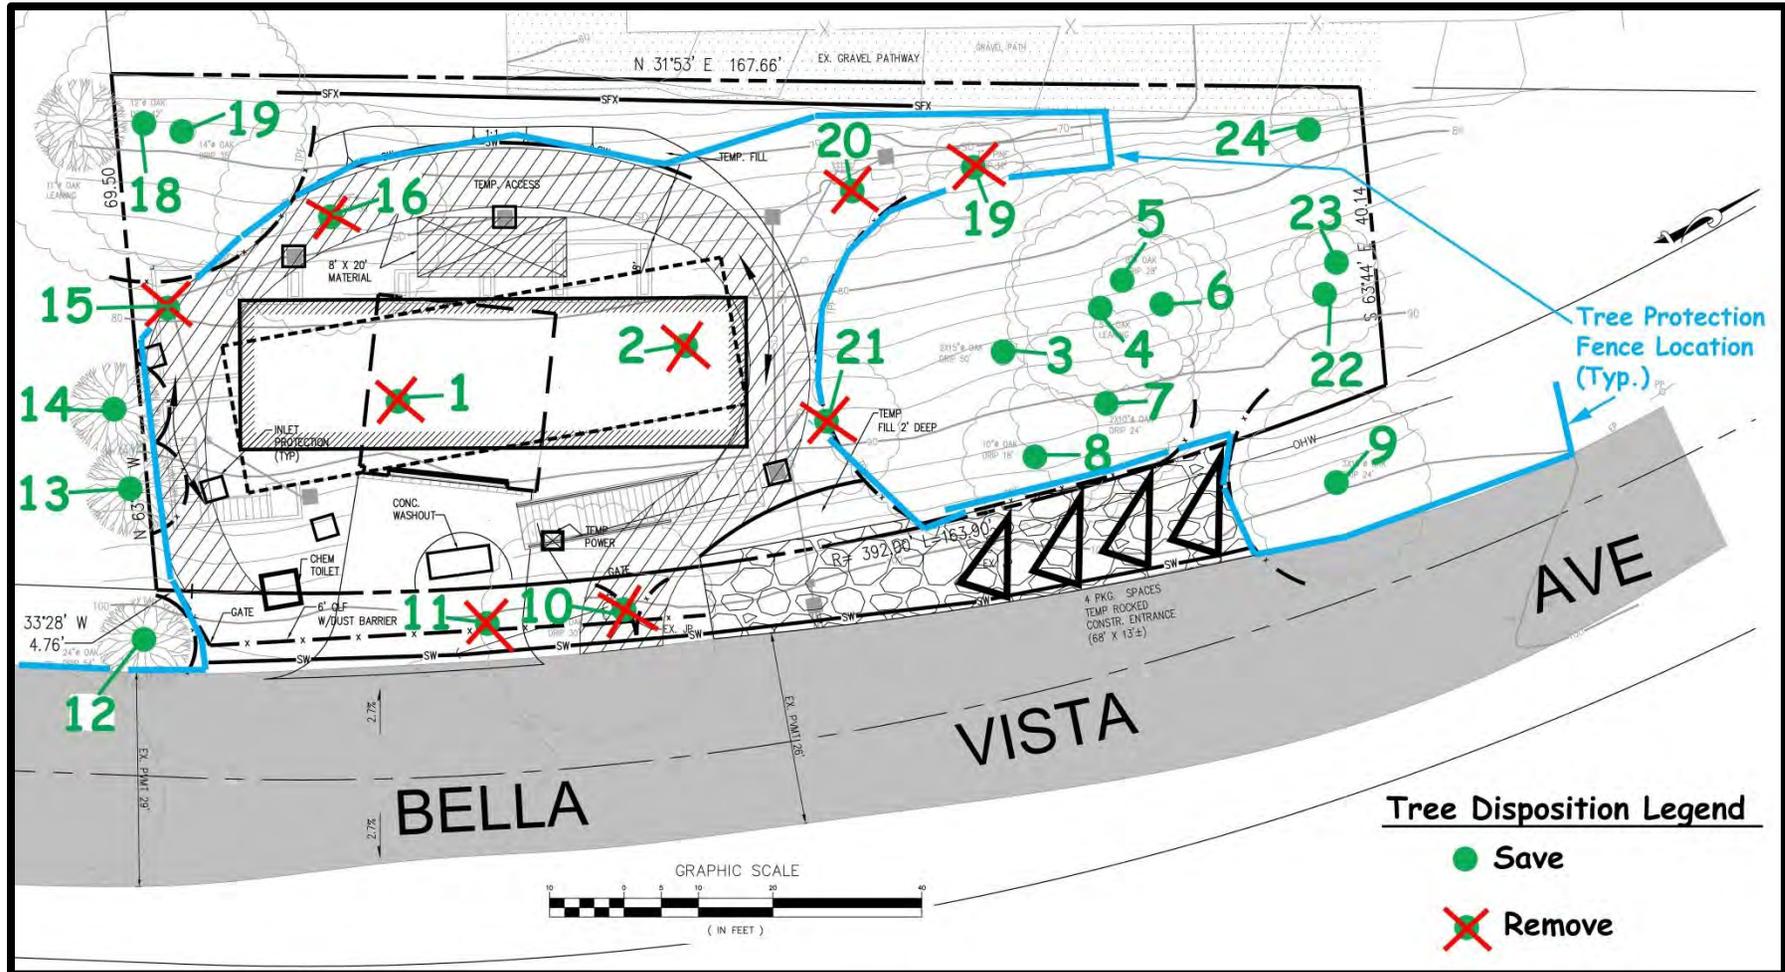
Tree Map (see Notes, page \_).

- The following 7 protected trees will be removed: **#1, 2, 10, 11, 15, 19, and 21.**
- The following 3 trees of less than protected size will be removed: **#4, 16 and 20.**
- The following 14 protected trees will be saved and protected: **#3, 5, 6, 7, 8, 9, 12, 14, 14, 17, 18, 22, 23 and 24.**
  - Of the above 14 trees, **#12, 13 and 14** are on neighboring property to the south.

1. The plan sheet used for the Tree Map is the *Site Logistics & Construction Management Plan*, sheet C-3. All of the proposed improvements shown on the 9/5/14 C-Sheets (C1-4) are not shown on this plan, so it may not be obvious why a particular tree is shown to be removed. Read the "Action" and "Notes" column in the Tree Table to find out why a particular tree is listed to be removed.
2. The *Trunk Diameter*, *Size* and *Condition* ratings in the *Tree Table* are from my last evaluation of the trees and the site on October 24, 2013. I did however, ride by the site last week to take a brief look around. The site and the condition of the trees do not seem to have changed appreciably since my October 2013 evaluation.

4. **Note the revised location for tree protection fencing** on the *Tree Map* in this report.
