Structural Observation Report

253 W. Main St.

Los Gatos, CA

Subject: Structural Observation Report
253 W. Main St.
Los Gatos, CA 95030
CSC job # 20-010

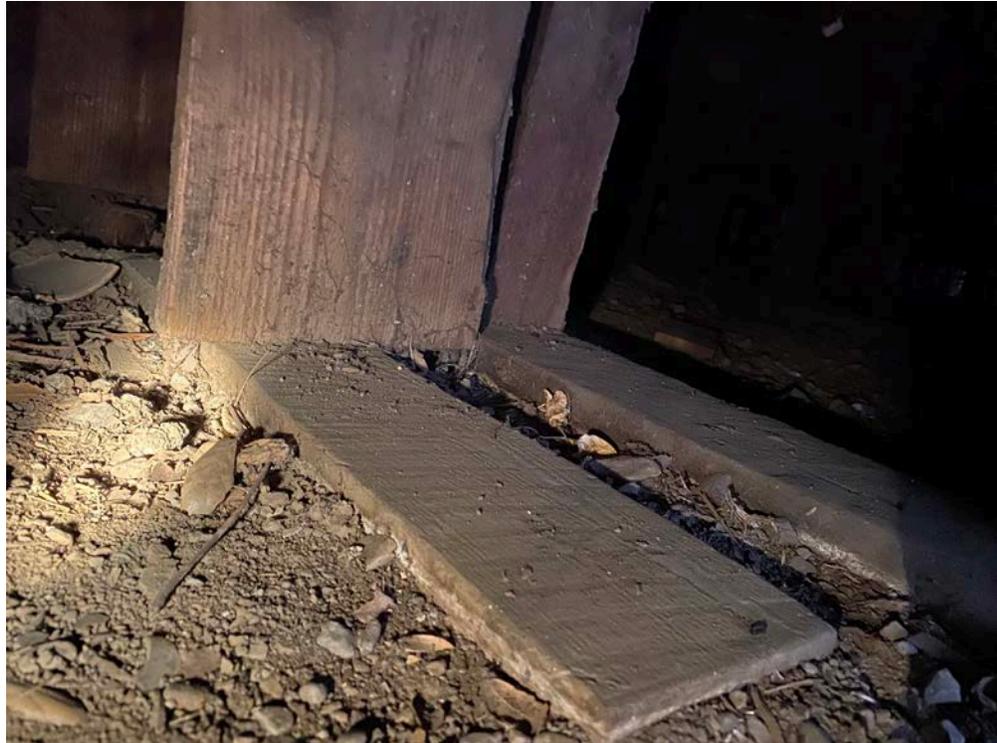
Photo 1

- Throughout the entire underfloor area, untreated wood cripple wall framing occurs which bears directly on top of lumber that is embedded in grade with improper wood to earth separation. It does not appear that any of the floor framing is moisture or decay resistant lumber and thereby subject to termite and dry rot deterioration. (See photo 1 and 4 in the appendix)

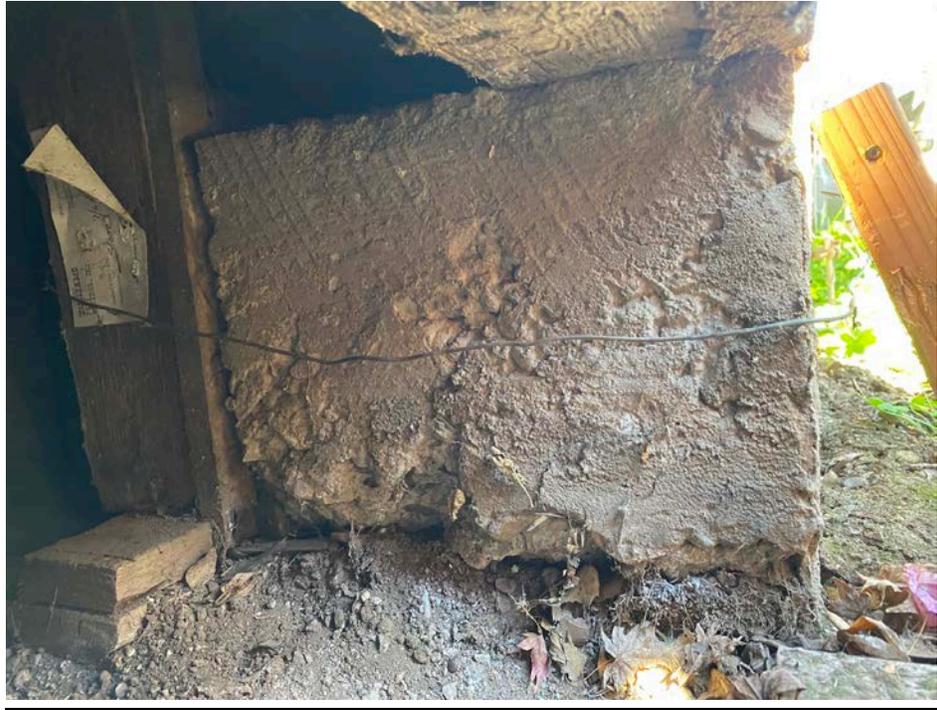
Photo 2

- Lack of significant, identifiable connections from walls, to rim board and rim board to mud sill (See photo 3 in the appendix)
- The embedment of the stemwall concrete footing is likely not 12” into grade(see photo #2 in the appendix)

- Due to the era of construction, the concrete stemwall footing is likely unreinforced and therefore unable to span across local soil irregularities and have any ductility in an earthquake event. (See photo 2 in the appendix)

- It appears that rainwater from downspouts, and landscape water has partially scoured away the dirt under portions of the exterior stemwall(see photo 2 in the appendix)

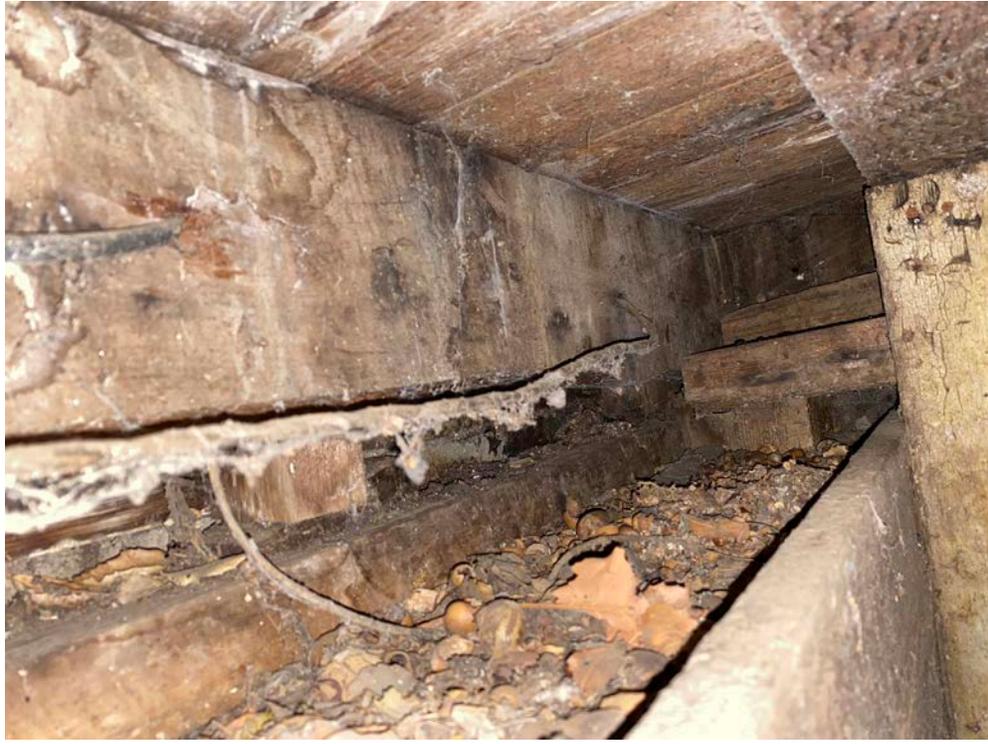
Photo 3

- Though it could not be seen, it is likely that there is a tremendous amount of dry rot damage and termite damage to the exterior walls studs.
- Lack of visible anchor bolts from mud sill to foundation(See photo 3 in the appendix)

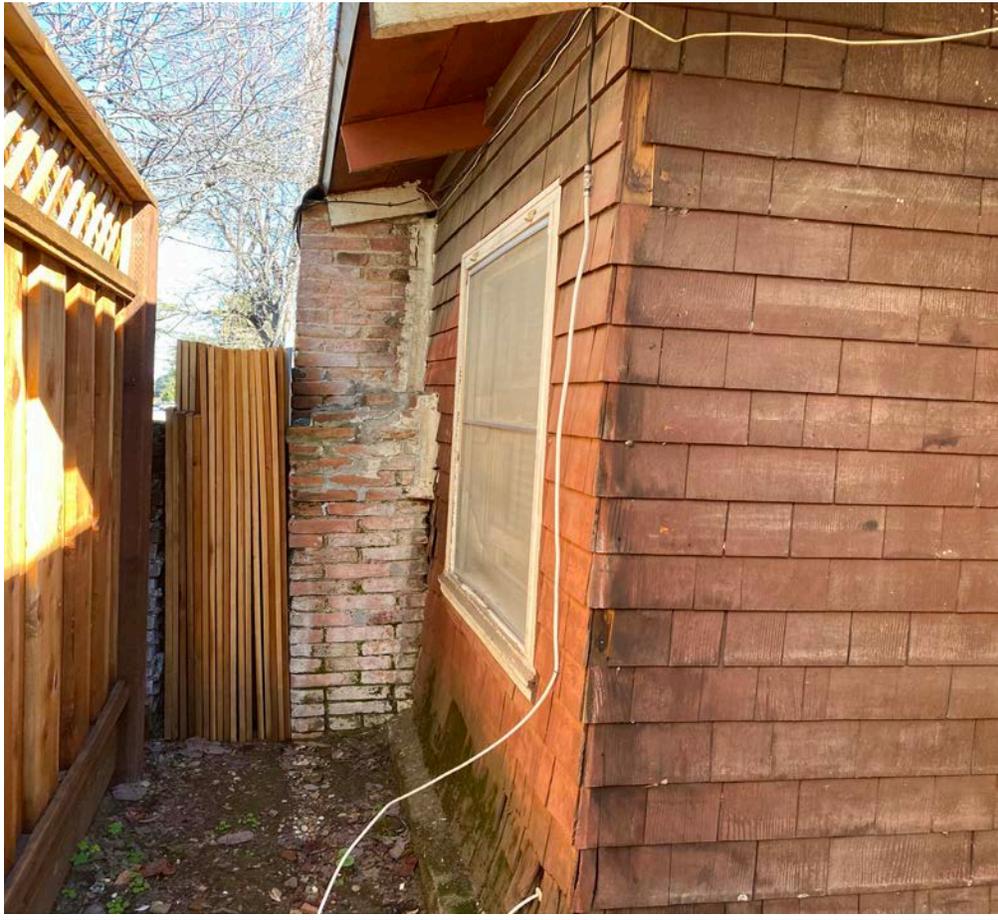
Photo 5

- Although the chimney has been cut down to the top of the roof level, the brick fireplace is not properly anchored to the wall and likely does not have an adequate footing located below it.(see photo 5 in the appendix)

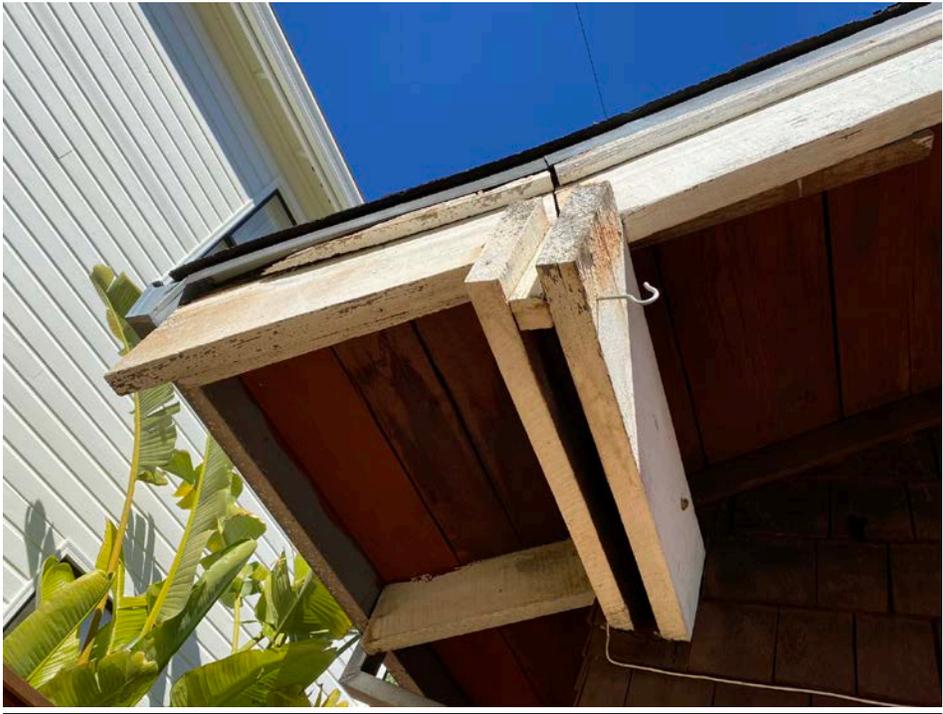
Photo 6

- Ceiling joists are not properly or adequately nailed to the rafters at the heel
- Eave rafters are not properly supported/braced where pitch change occurs(see photo 6 in appendix)

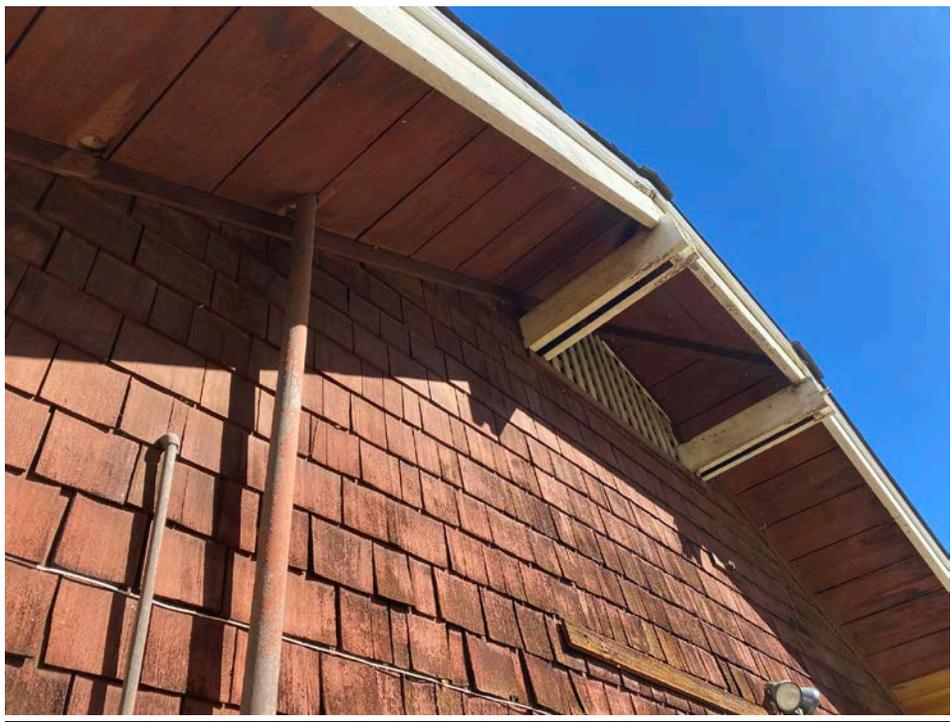
Photo 7

plate. This would result in poor performance of the lateral force resisting system in a heavy ground motion earthquake. In addition the gable walls appear to lack a sheathing system that can fully and completely transfer roof diaphragm forces to the exterior walls(see photo 7).

In order for this residence to meet current regulations and to make the house compliant for life safety, a proper lateral load path from the roof down to the foundation would need to be retrofitted, which would virtually affect every member from the roof to the foundation in one aspect or another.
