ARBORIST REPORT

The Luxe

14849 Los Gatos Boulevard
Los Gatos, CA 95032

March 6, 2024; *updated February 7, 2025*

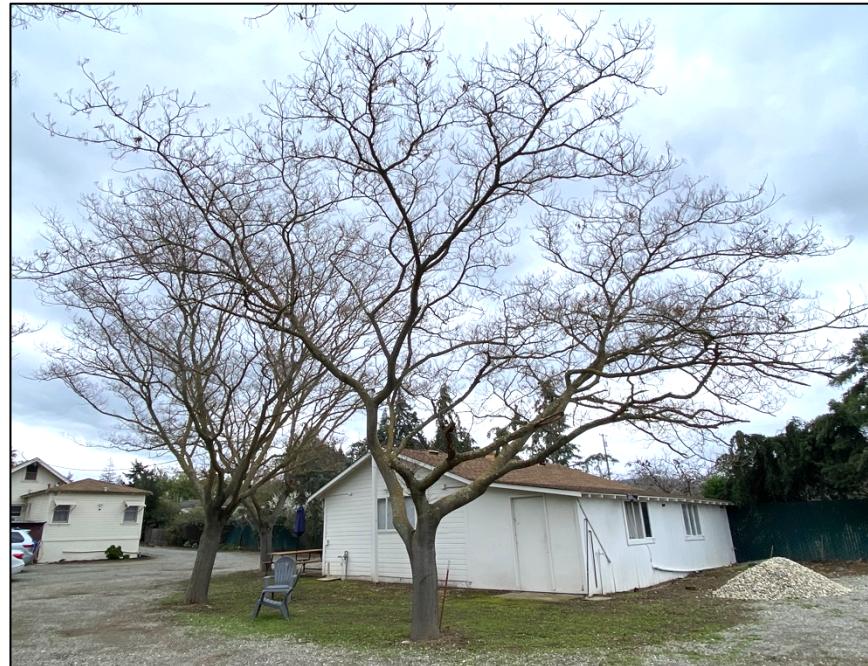
The most common species on the site was silk tree, with 13 trees. Only one of the trees was in good condition (#17, Photo 1); the

Photo 1: Silk trees #17 and 18 were in good and fair condition. Trees were dormant.

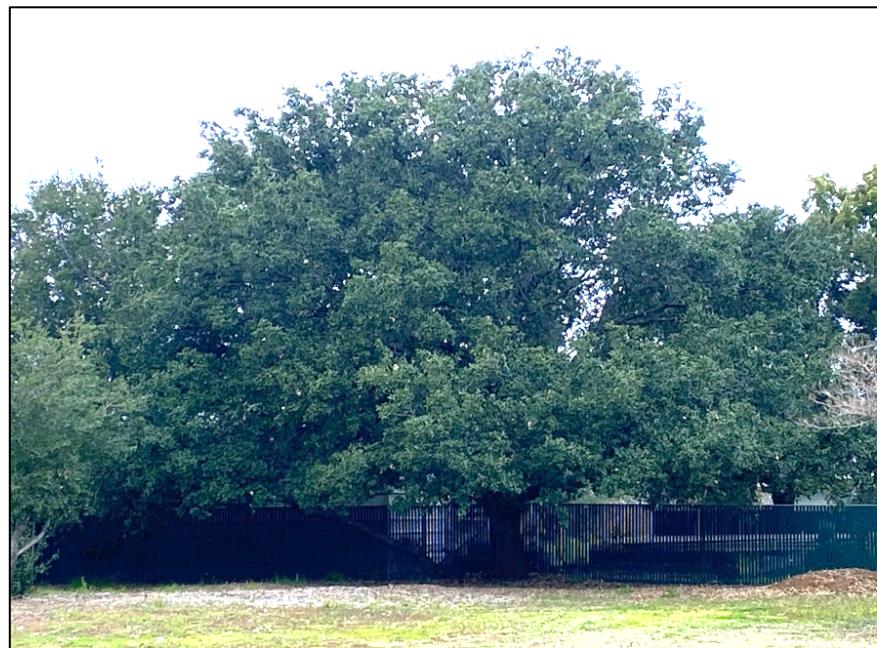
Coast live oak was the second most common species on the site. Many trees were small volunteer plants scattered around the site. Tree #20 was the largest, with a 26-inch diameter trunk. It was in excellent condition with a dense, spreading crown (Photo 2).

Photo 2: Coast live oak #20 at the rear of the site was in excellent condition.

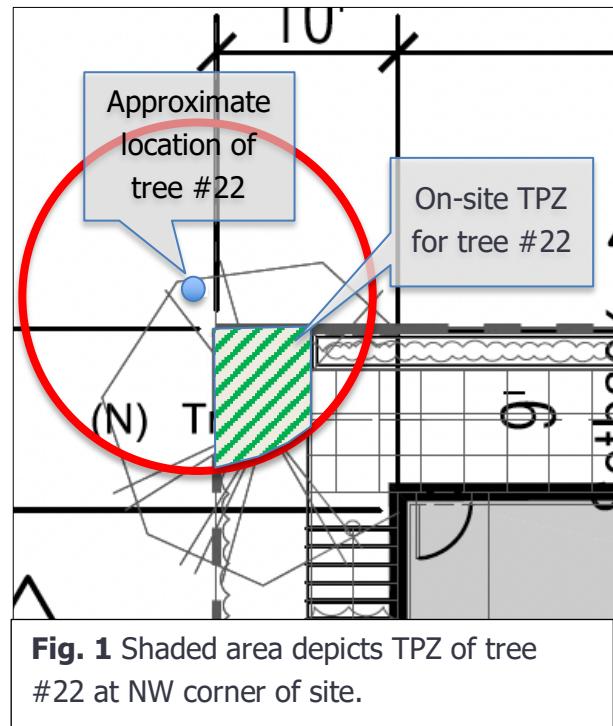
1. Provide sufficient clearance between trees and proposed features to avoid damage to roots.
2. A tree protection zone (TPZ) should be established for trees to be preserved.
 - a. The tree protection zone for tree #22 shall be the 5' setback from the rear (west) property line (Fig. 1). This area shall be protected with trench plates or plywood over coarse woodchip mulch.
