ARBORIST REPORT

June 21, 2024
Revised February 13, 2025
6862.00

647 N. Santa Cruz Avenue
Los Gatos, CA

HMH
1570 Oakland Road
San Jose, CA 95131
William Sowa
ISA Certified Arborist #WE-12270A

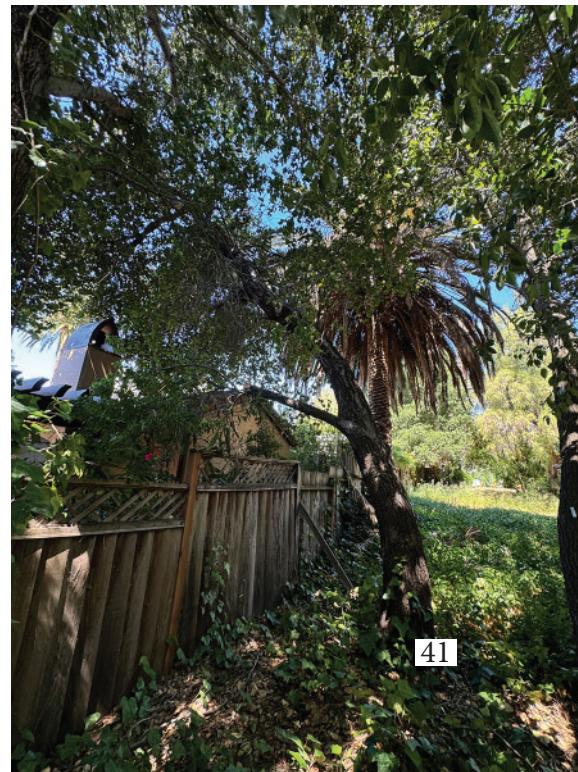
41

The Coast Live Oaks are in moderate to poor shape. They have more or less naturalized in the space provided from them and this has resulted in stunted canopy growth, leaning truck tapers and poor structure development. Due to the overcrowding of these trees and the trees around them there is cluster type relationship to the trees adjacent to them. It is likely that development will impact these trees.

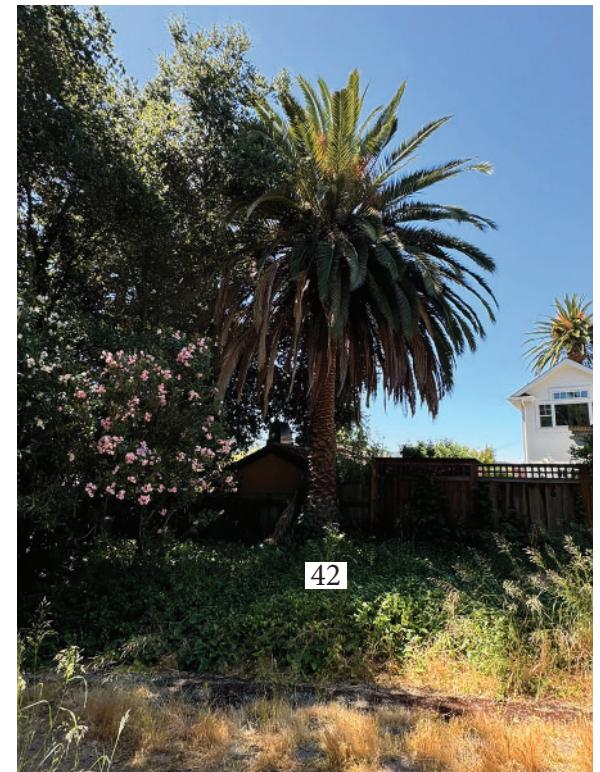
42

The date palm tree is a mature specimens that look to be in good shape and appearance although like other trees it has not been very well maintained. Pruning off the lower four feet of dead fronds would clean up the tree. There has been an uptick of several major, potentially lethal diseases attacking landscape palms in California. The best strategy for managing these diseases is an integrated approach that combines prevention, exclusion, sanitation, and proper care. Development is likely to impact this tree.
