ARBORIST REPORT

June 27, 2024
6866.00

Residence at Newtown
15495 Los Gatos Blvd.
Los Gatos, CA

Swenson Builders

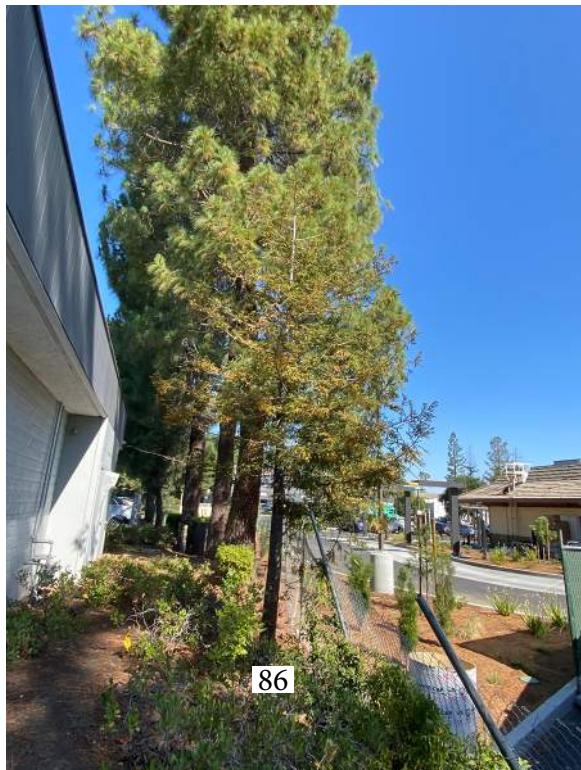
86

The coast redwoods are the most common tree on the site comprising 50% of all the trees. Trees 1-7 are near a vehicular entrance at the edge of the property which are in good health and shape. Trees 30-57 and 59-67 line the west side of the property and the northwest corner. They are all in good to moderate health and shape. Tree 32 has signs of stress, thinning and branch die back. There is some concrete at the base of the tree, which may have affected it's development. The trees on either side of it have some canopy missing towards it. Trees 53 – 56 are somewhat crowded next to each other. Trees 60 – 65 and 73 are growing crowded next to a building and have uneven canopies. In general most of the trees have signs of stress, but are in fair condition. It is common for coast redwoods to have signs of stress in this area because they thrive near the coast where they get regular fog. They don't handle drought well and require large amounts of water.

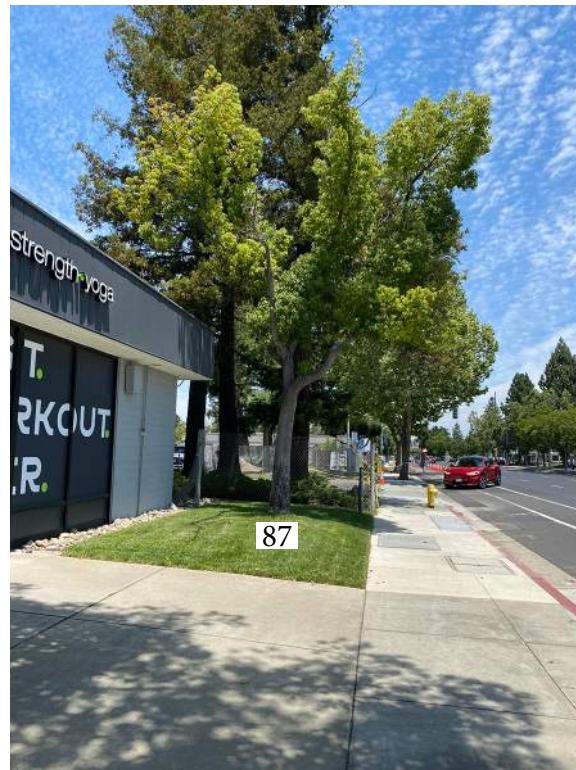
87

The camphor trees are within the parking area and along the frontage. They are all in moderate shape and health. The trees in the parking area, 9-10, 20-21, 24, many have surface roots due to the small planting islands. The parking area and frontage trees have signs of stress and crown die back.
