Town of Los Gatos

Request for Proposals – Oak Meadow Bandstand Area Improvements Questions and Answers 11/22/2021

Oak Meadow Park

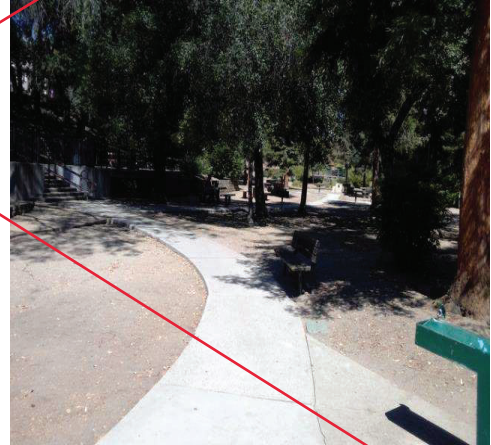
**Path Through Single Family Picnic Area
Exterior Walkway**

Path of Travel : Walking Surface Cross Slope

There are cross slopes greater than allowed on the primary path of travel.

On-Site Finding 3.60 percent for 75.00 feet

Code Reference ADA 402, 403.3, CA 11B-403.3

Provide a compliant path of travel.

Recommendation Up to 2.08 percent

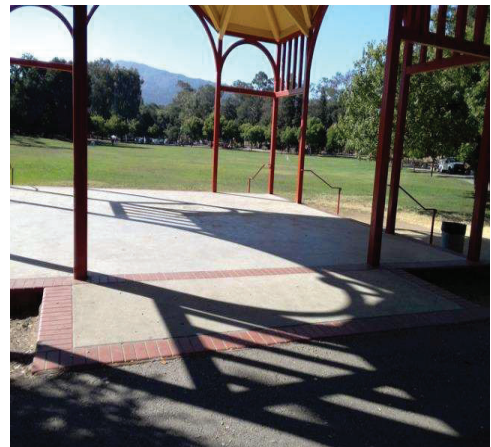
**Path to Bandstand
Change in Elevation**

Path of Travel : Change in Level

There is a change in elevation greater than recommended value.

On-Site Finding 0.62 inches

Code Reference ADA 303, 403.4, CA 11B-303,403.4

Ensure that the change in elevation is within the recommended value.

Recommendation Up to 0.25 inches

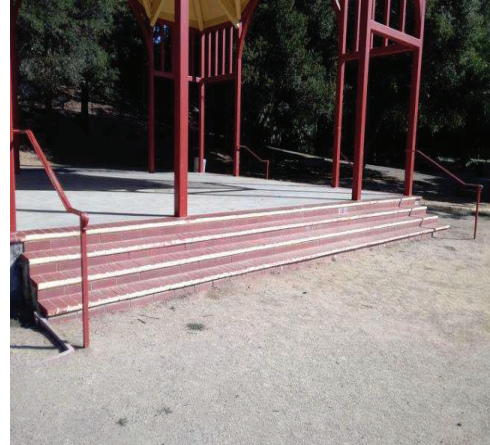
East Stairs to Bandstand

Stairs : Risers Height

The height of the risers are not uniform.

On-Site Finding Not Uniform

Code Reference ADA 504, CA 11B-504.2

Modify or replace the stairs to provide uniform riser height.

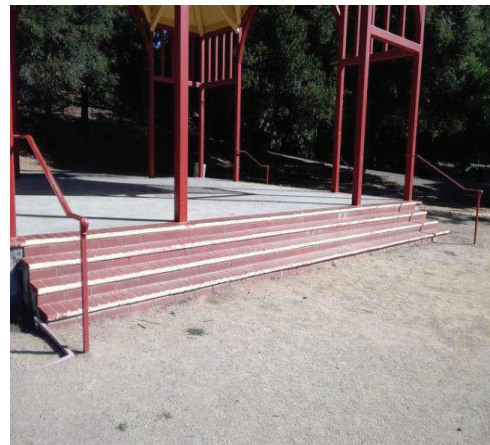
East Stairs to Bandstand

Stairs : Risers Striping Width

There is detectable striping affixed to each tread of the stairway, however the strips do not contrast in color from that of the treads or are not at least two inches in width.

On-Site Finding 1.00 inches

Code Reference ADA 504, CA 11B-504.4

Replace the detectable striping on each tread of the stairway with detectable striping that clearly contrasts in color and is at least 2 inches in width placed no more than 1 inch from the tread nose or landing.

Recommendation 2.00 - 4.00 inches

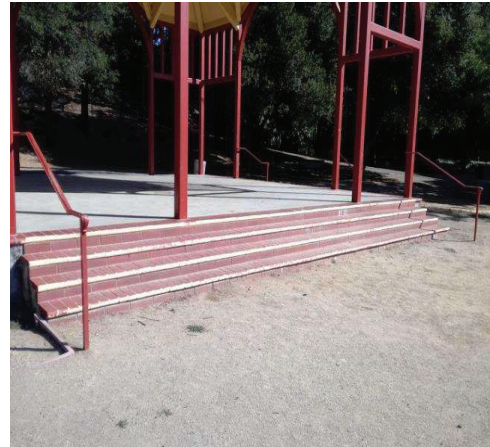
Run 1 Left Handrail

Stairs : Handrail Diameter

The diameter of the handrails is not within the required range.

On-Site Finding 2.25 inches

Code Reference ADA 505, 504.6, 505.7, CA 11B-505.7

Replace the handrails on each side to provide a smooth and continuous gripping surface diameter within the required range.

Recommendation 1.25 - 2.00 inches

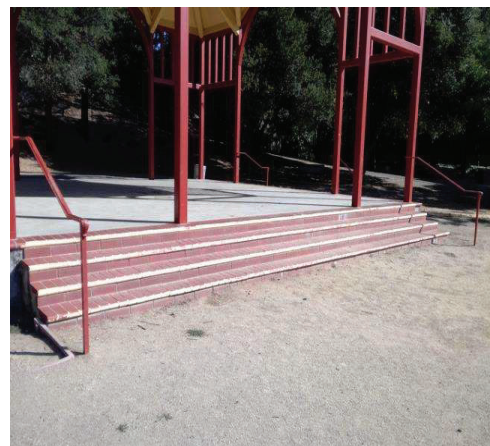
Run 1 Right Handrail

Stairs : Handrail Diameter

The diameter of the handrails is not within the required range.

On-Site Finding 2.25 inches

Code Reference ADA 505, 504.6, 505.7, CA 11B-505.7

Replace the handrails on each side to provide a smooth and continuous gripping surface diameter within the required range.

Recommendation 1.25 - 2.00 inches

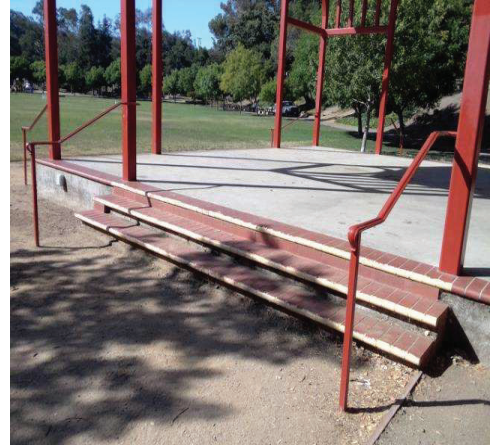
North Stairs to Bandstand

Stairs : Risers Height

The height of the risers are not uniform.

On-Site Finding Not Uniform

Code Reference ADA 504, CA 11B-504.2

Modify or replace the stairs to provide uniform riser height.

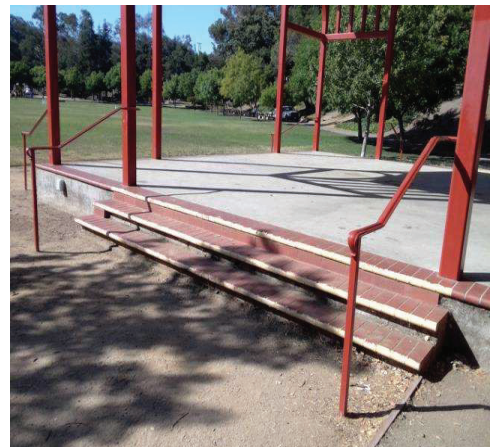
North Stairs to Bandstand

Stairs : Riser Nosing Projection

The projection of the nosing on the stairway is greater than required.

Code Reference ADA 504, 504.5

Modify the nosing on the stairway so that the nosing is curved or beveled and do not project more than required over the tread below.

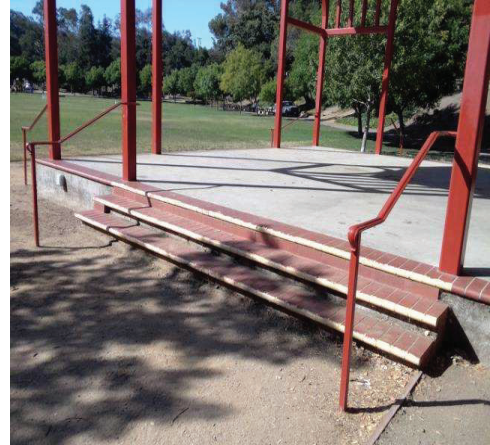
North Stairs to Bandstand

Stairs : Riser Uniform Tread Depth

The treads do not have a uniform depth.

Code Reference ADA 504.2, CA 11B-504.2

Modify or replace the stairs to provide compliant treads.

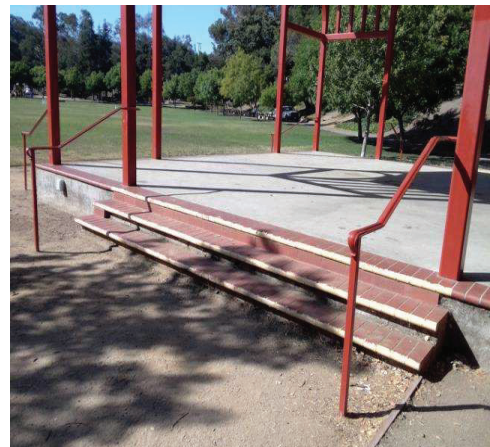
North Stairs to Bandstand

Stairs : Risers Striping Width

There is detectable striping affixed to each tread of the stairway, however the strips do not contrast in color from that of the treads or are not at least two inches in width.

On-Site Finding 1.00 inches

Code Reference ADA 504, CA 11B-504.4

Replace the detectable striping on each tread of the stairway with detectable striping that clearly contrasts in color and is at least 2 inches in width placed no more than 1 inch from the tread nose or landing.

Recommendation 2.00 - 4.00 inches

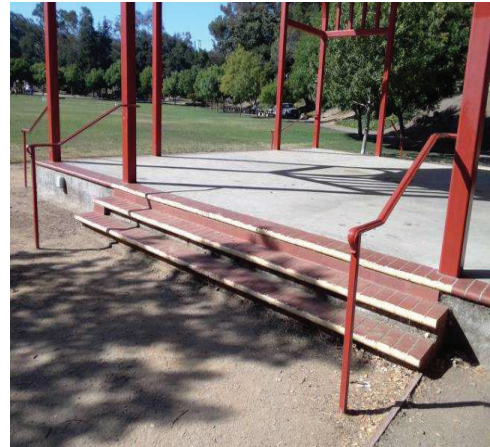
Run 1 Left Handrail

Stairs : Handrail Diameter

The diameter of the handrails is not within the required range.

On-Site Finding 2.25 inches

Code Reference ADA 505, 504.6, 505.7, CA 11B-505.7

Replace the handrails on each side to provide a smooth and continuous gripping surface diameter within the required range.

Recommendation 1.25 - 2.00 inches

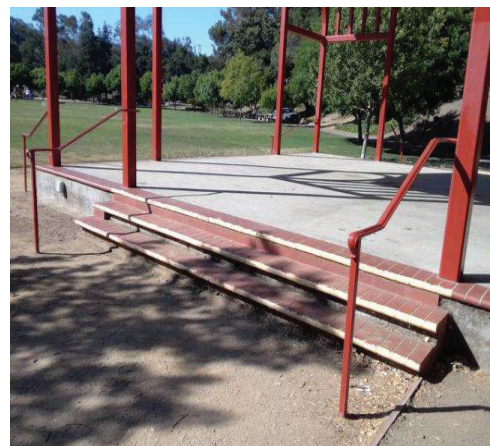
Run 1 Right Handrail

Stairs : Handrail Diameter

The diameter of the handrails is not within the required range.

On-Site Finding 2.25 inches

Code Reference ADA 505, 504.6, 505.7, CA 11B-505.7

Replace the handrails on each side to provide a smooth and continuous gripping surface diameter within the required range.

Recommendation 1.25 - 2.00 inches

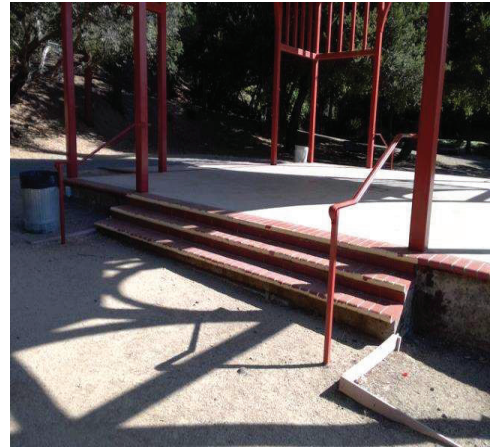
South Stairs to Bandstand

Stairs : Risers Striping Width

There is detectable striping affixed to each tread of the stairway, however the strips do not contrast in color from that of the treads or are not at least two inches in width.

On-Site Finding 1.00 inches

Code Reference ADA 504, CA 11B-504.4

Replace the detectable striping on each tread of the stairway with detectable striping that clearly contrasts in color and is at least 2 inches in width placed no more than 1 inch from the tread nose or landing.

Recommendation 2.00 - 4.00 inches

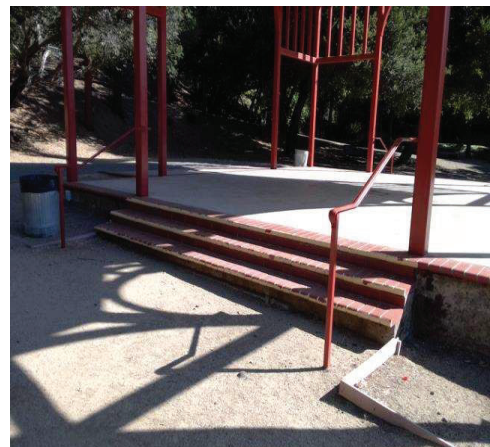
South Stairs to Bandstand

Stairs : Riser Nosing Projection

The projection of the nosing on the stairway is greater than required.

Code Reference ADA 504, 504.5

Modify the nosing on the stairway so that the nosing is curved or beveled and do not project more than required over the tread below.

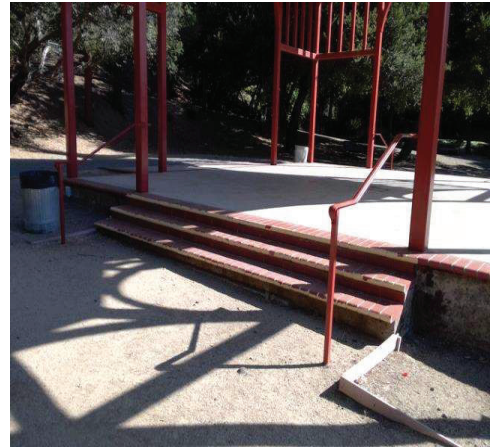
Run 1 Left Handrail

Stairs : Handrail Diameter

The diameter of the handrails is not within the required range.

On-Site Finding 2.25 inches

Code Reference ADA 505, 504.6, 505.7, CA 11B-505.7

Replace the handrails on each side to provide a smooth and continuous gripping surface diameter within the required range.

Recommendation 1.25 - 2.00 inches

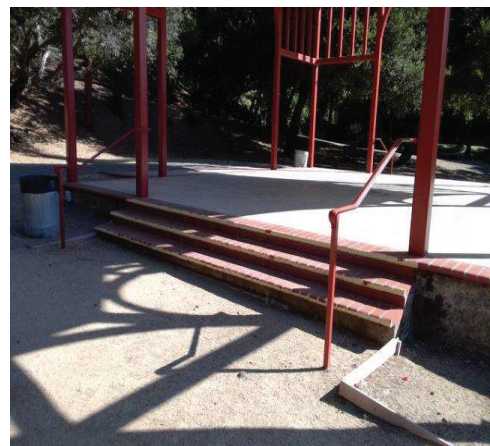
Run 1 Right Handrail

Stairs : Handrail Diameter

The diameter of the handrails is not within the required range.

On-Site Finding 2.25 inches

Code Reference ADA 505, 504.6, 505.7, CA 11B-505.7

Replace the handrails on each side to provide a smooth and continuous gripping surface diameter within the required range.

Recommendation 1.25 - 2.00 inches
