**ATTACHMENT 2
GEOLOGIC AND GEOTECHNICAL
STUDY**

**UPDATED GEOLOGIC AND GEOTECHNICAL STUDY
PROPOSED RESIDENTIAL DEVELOPMENT**

**ROSS PROPERTY
339 AND 341 BELLA VISTA AVENUE
LOS GATOS, CALIFORNIA**

25 June 2015
Document Id. 15068C-01R1

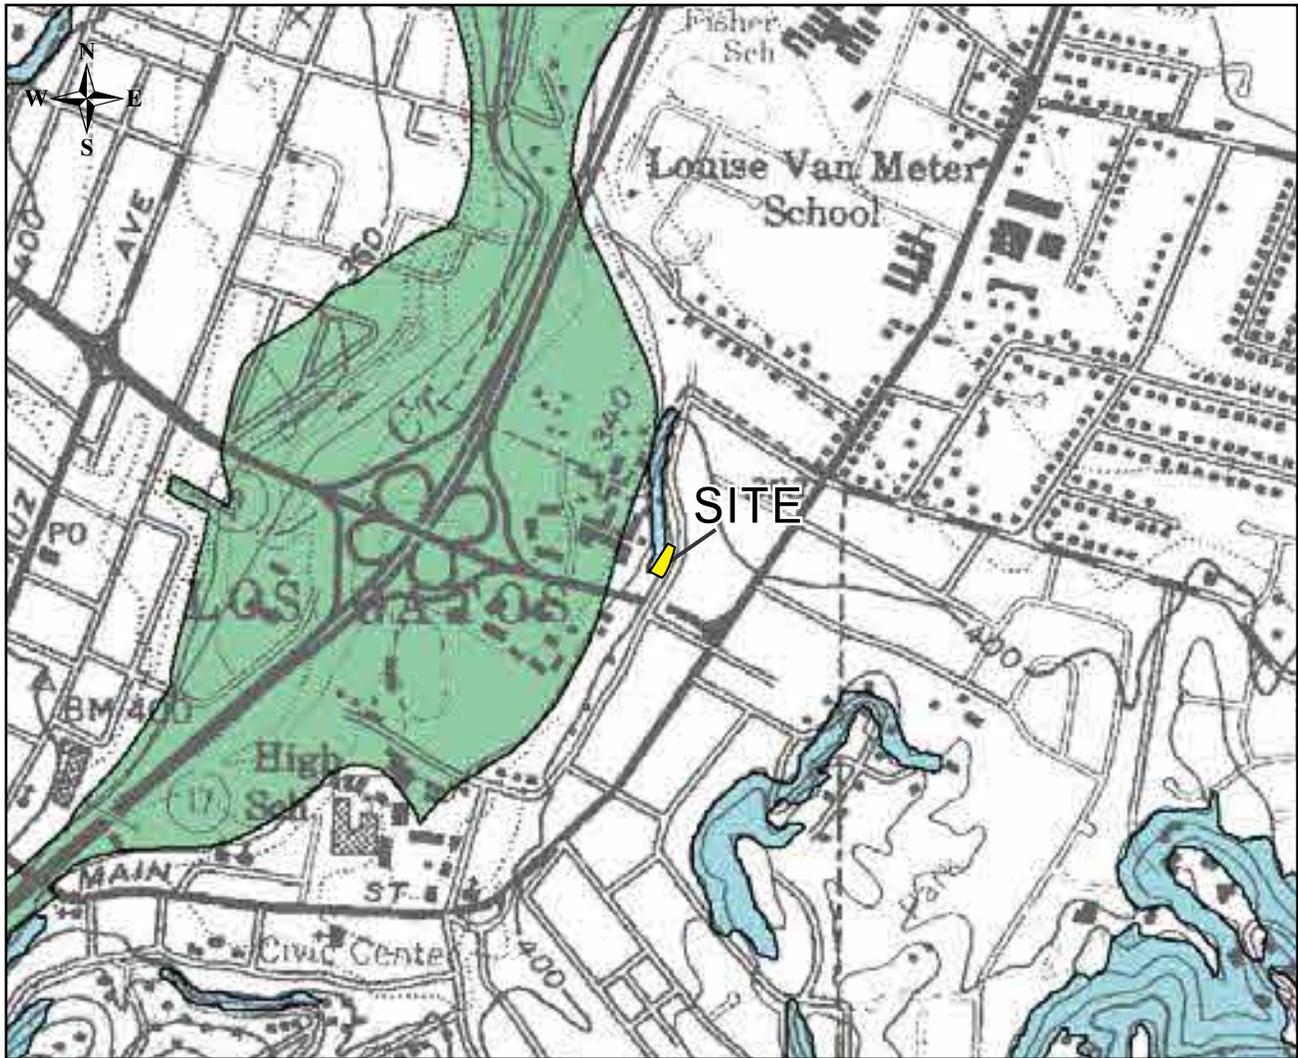
Figure 3

- **Earthquake-Induced Landslides;** Areas where previous occurrence of landslide movement, or local topographic, geological, geotechnical, and subsurface water conditions indicate a potential for permanent ground displacements.

While there is no evidence of landsliding in the site vicinity, the northwestern edge of the site is mapped within a State of California Seismic Hazard Zone for earthquake-induced landsliding (see Figure 3, Regional Seismic Hazard Zones Map). The same area is also mapped near a zone designated as having a “landslide potential” on the Town's Landslide Hazard Areas map (see Figure 4, Local Landslide Hazard Areas Map). These zones were established to minimize the loss of life and property by identifying and mitigating seismic hazards related to landslides. Consequently, we have conducted a qualitative slope stability evaluation of the northwest-facing slope to evaluate the risk of landsliding.

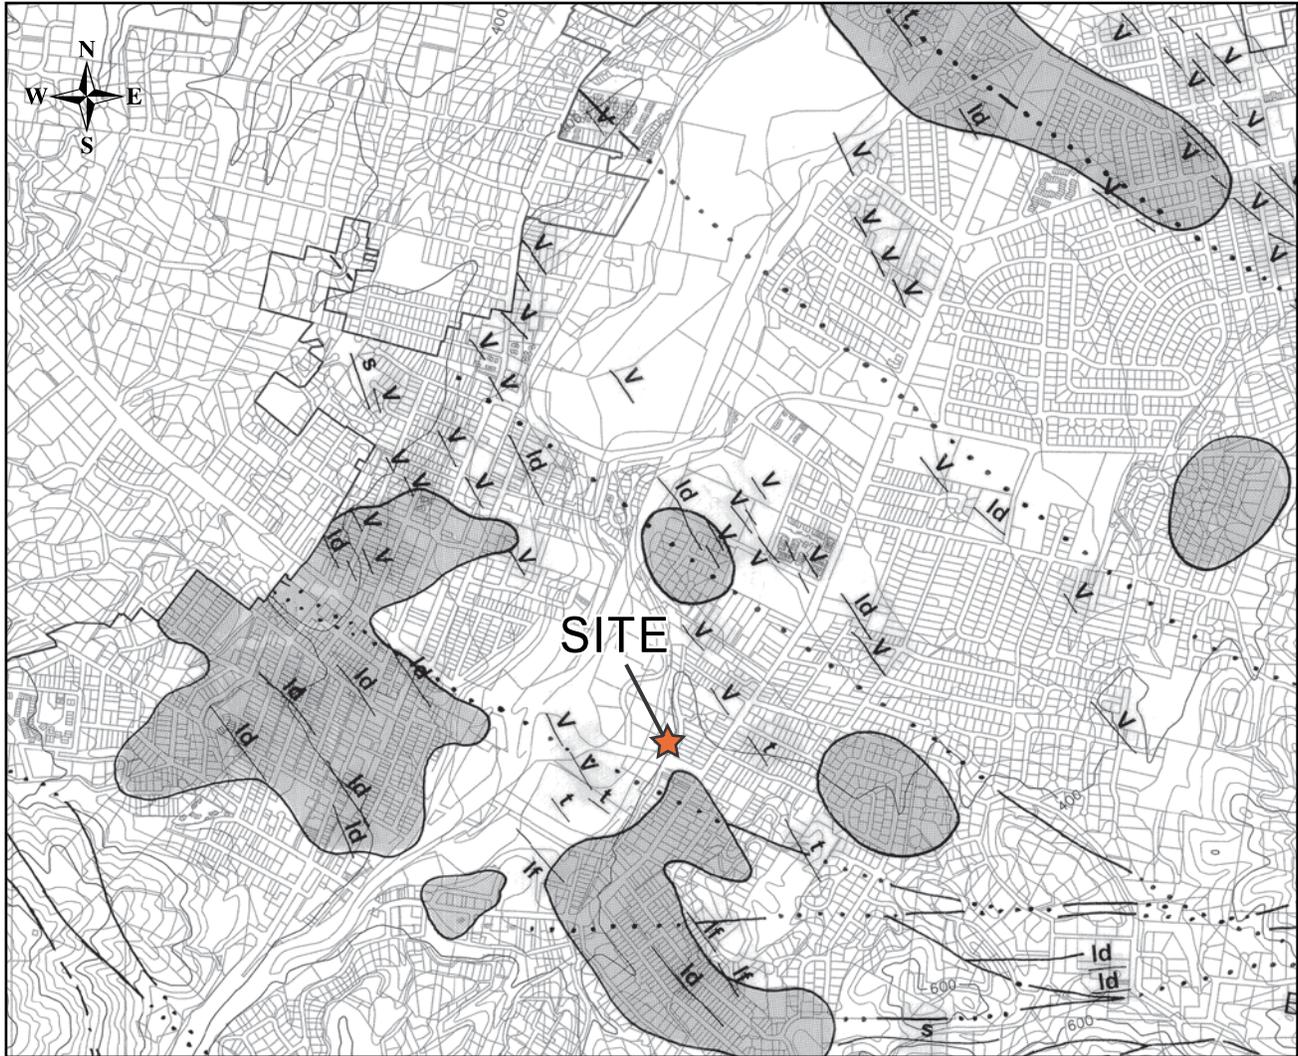
BASE: Town of Los Gatos General Plan Update; Fault, Lineament & Coseismic Deformation Map; Plate #3; NOLAN ASSOCIATES; 1/17/99

According to geologic mapping by McLaughlin et al., (2001), the site is situated near a concealed trace of the potentially active Shannon fault (see Figure 2). Because of the proximity to this and other faults within the region, the site is mapped within a zone of high fault rupture potential by the Town of Los Gatos (see Figure 5, Local Fault Rupture Potential Map). These zones were created based upon the Faults, Folds, and Zones of Lineaments Map by William Lettis and Associates, Inc., 1994 (see Figure 6) and the Fault, Lineament, and Coseismic Deformation Map by Nolan Associates, 1999 (see Figure 7).

Our review of prior studies on the subject property revealed a relatively uniform layer of alluvial fan deposits, with no evidence suggestive of fault offset through the subject site. Lineaments shown on Figure 7 (Nolan Associates, 1999) do not correlate with the trend of the concealed fault trace that was mapped southwest of the subject site by McLaughlin et. al., 2001 (see Figure 2). We encountered no evidence suggesting that the fault trace crosses beneath the subject site.

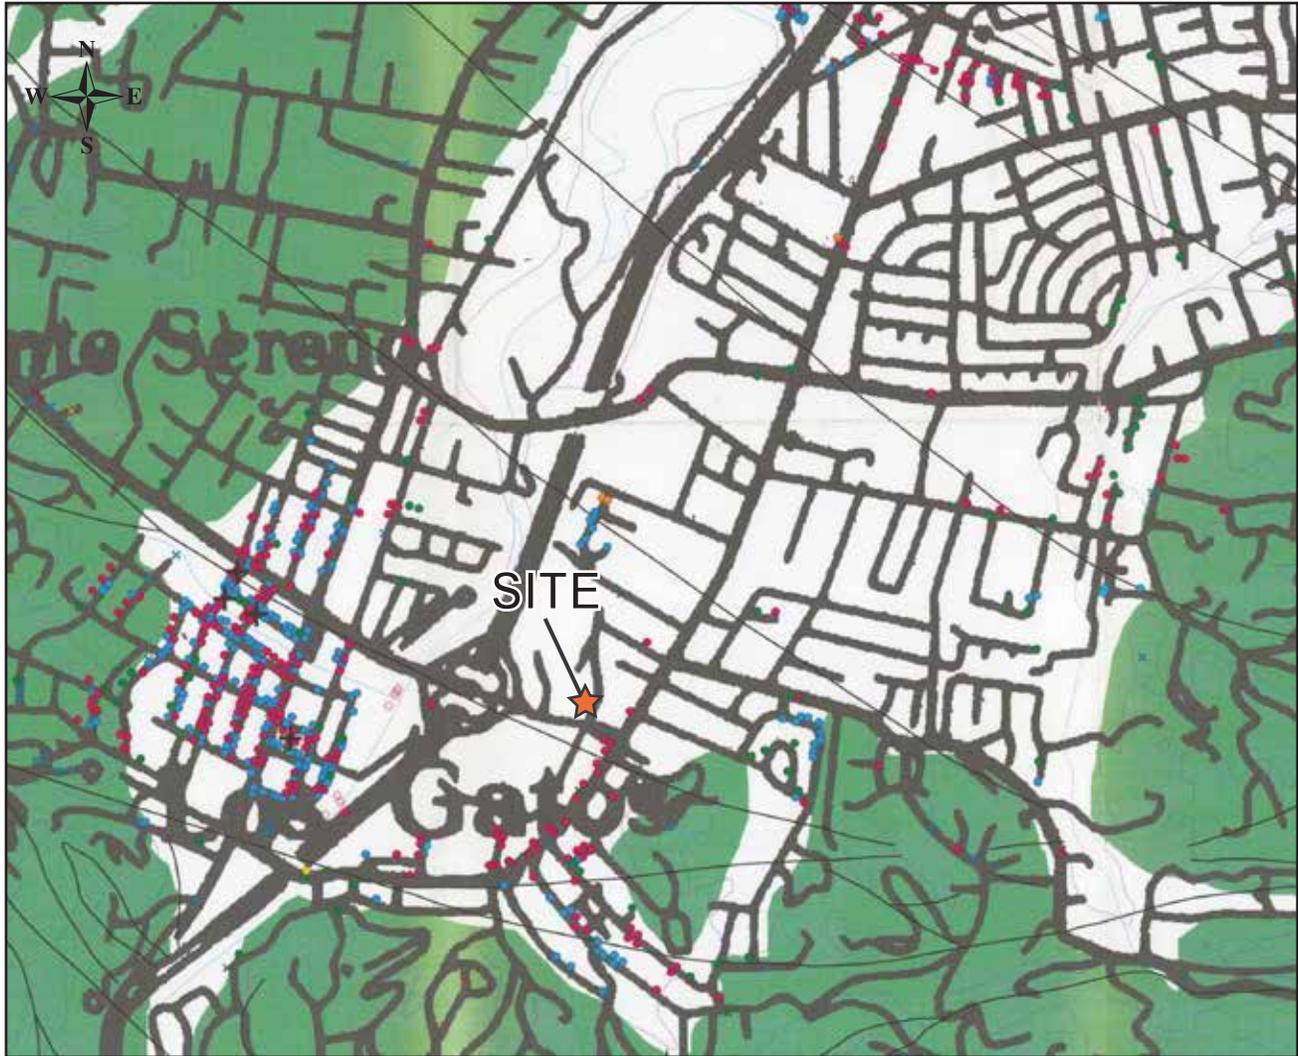
Figure 8

- Fresh pavement break or buckle suggestive of contractional deformation (reported by USGS; some also reported by local governments)
- Apparently fresh pavement break with unspecified sense of deformation (reported by USGS; some also reported by local governments)
- Pavement break with unspecified sense of deformation (reported by local governments)
- Combination of pre-earthquake and coseismic break in pavement (reported by USGS and local governments)

We reviewed selected geologic and geologic hazard maps, aerial photographs, our prior reports, and other consultant's reports for studies performed for the subject site and nearby sites to evaluate the prevailing geologic conditions of the site and vicinity. Regional and local geologic and geologic hazard maps are presented on Figures 2 through 8.
